**NOMINATION OF HISTORIC BUILDING, STRUCTURE, SITE, OR OBJECT
PHILADELPHIA REGISTER OF HISTORIC PLACES
PHILADELPHIA HISTORICAL COMMISSION**

Street address: 714-16 West Girard Avenue

Historic Name: National Security Bank

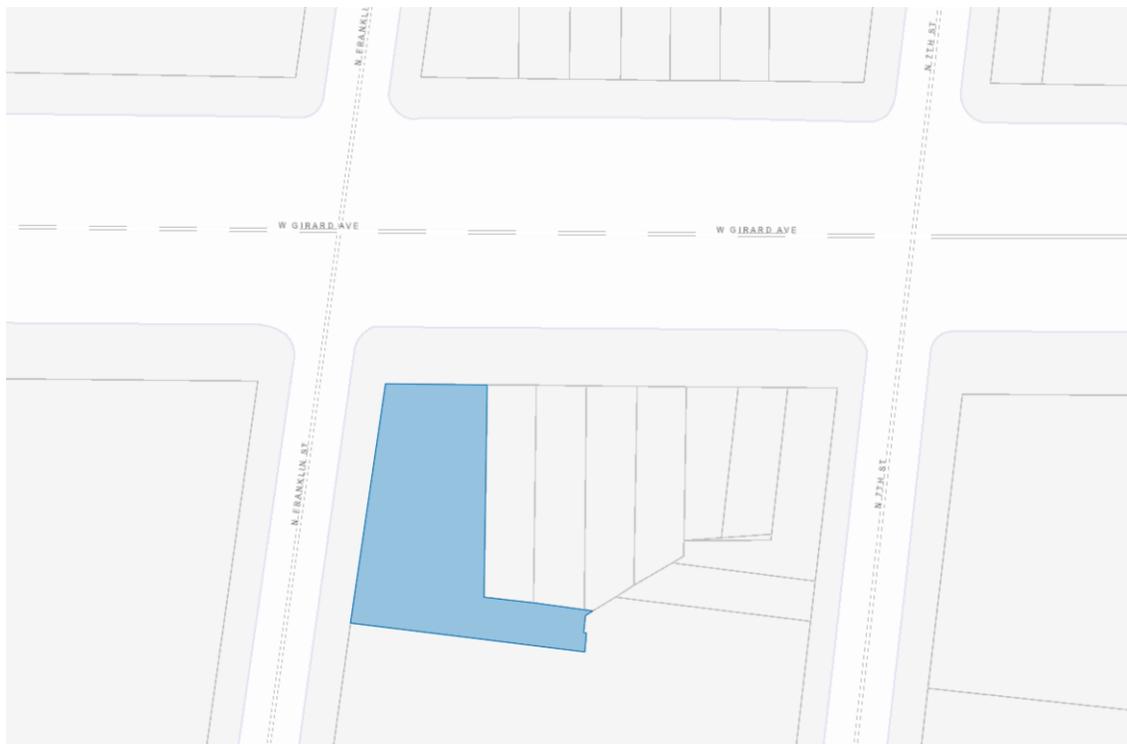
Figure 2: Boundary outlines of 714-16 West Girard Avenue. Image courtesy City of Philadelphia, Department of Records.

The boundary description of 714-16 West Girard Avenue is as follows:

Situate at the intersection of the Southerly side of Girard Avenue and the Easterly side of Franklin Street; thence extending Eastwardly along the said Southerly side of Girard Avenue forty feet, five and one-half inches to a point, thence extending Southwardly on a line at right angles to said Girard Avenue, eighty-five feet, eleven and seven-eighths inches to a point, thence extending Eastwardly on a line at right angles to said Franklin Street thirty-nine feet, ten and seven-sixteenths inches to a point; thence extending Southwardly along a retaining wall on a line at right angles to said Girard Avenue, nine feet and one-half of an inch to an angle in said retaining wall, thence extending Eastwardly at right angles to Seventh Street, ten and five-eighths inches to a point; thence extending Southwardly on a line parallel with Seventh Street, six feet, ten and five-eighths inches to a point; thence extending Westwardly on a line at right angles to Franklin Street ninety-three feet, two and five-eighths inches to a point on the Easterly side of said Franklin Street and thence extending Northwardly along the Easterly side of said Franklin Street ninety-five feet, eleven and one-fourth inches to a point on the Southerly side of said Girard Avenue, the place of beginning.

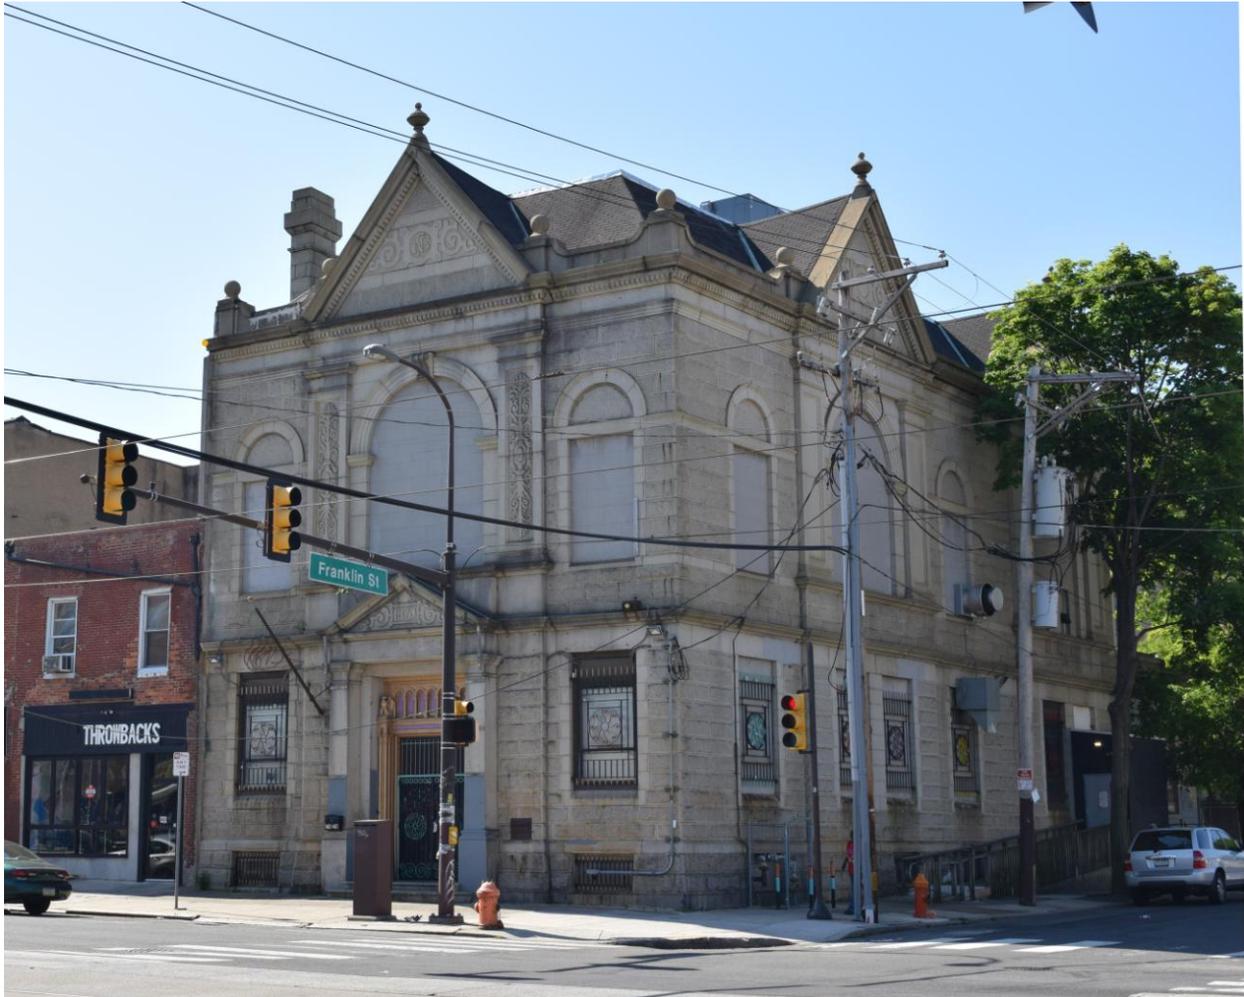
Figure 3: The National Security Bank. Looking southeast from the intersection of Franklin and West Girard Avenues. Photograph by author, 2017.

The National Security Bank (Fig. 3) is a two-and-half story corner building with its primary elevations on West Girard Avenue (the façade) and Franklin Street (west elevation). Both elevations are faced in rusticated Fox Island Granite with recessed joints. The first-floor fenestration is covered by decorative iron window guards, almost certainly original.² The south elevation is faced with red brick and the eastern elevation is a party wall. The hipped roof is faced in asphalt shingles.

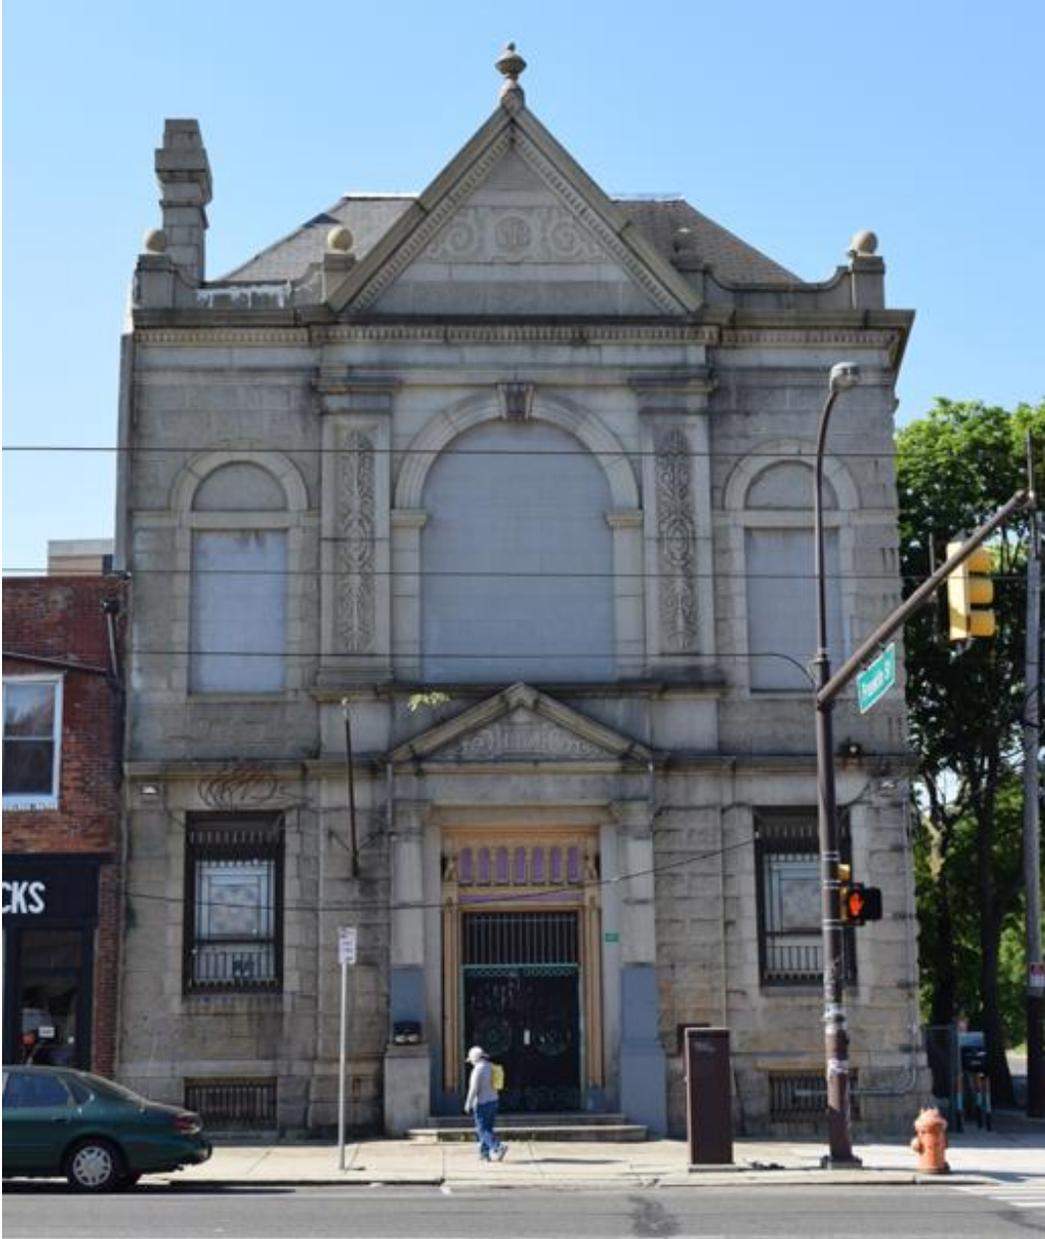
Figure 4: West Girard Avenue façade. Photograph by the author, 2017.

The West Girard Avenue façade (fig. 4) is three bays wide and built on a slight incline. The first floor of the façade is dominated by the central door surround and pediment (fig. 5). The double entry doors are covered with decorative iron window guards. The (non-contributing) turquoise paint highlights the abstract, curving design. Flanking the doors are gold-painted stylized engaged columns capped by arches supporting eagles (fig. 6). The highly-decorated transom's most notable feature is a miniature Romanesque colonnade running between the eagles. The stone surround itself is overtly classical. Pilasters with egg-and-dart capitals support an unornamented architrave culminating in a pediment with strapwork and the year of the bank's founding (1870). The pilasters that support the architrave and pediment have several wood nailers attached to them that would have supported signage or similar. The lower region of both pilasters has a painted coating, and the eastern pilaster has a modern mailbox attached to it.

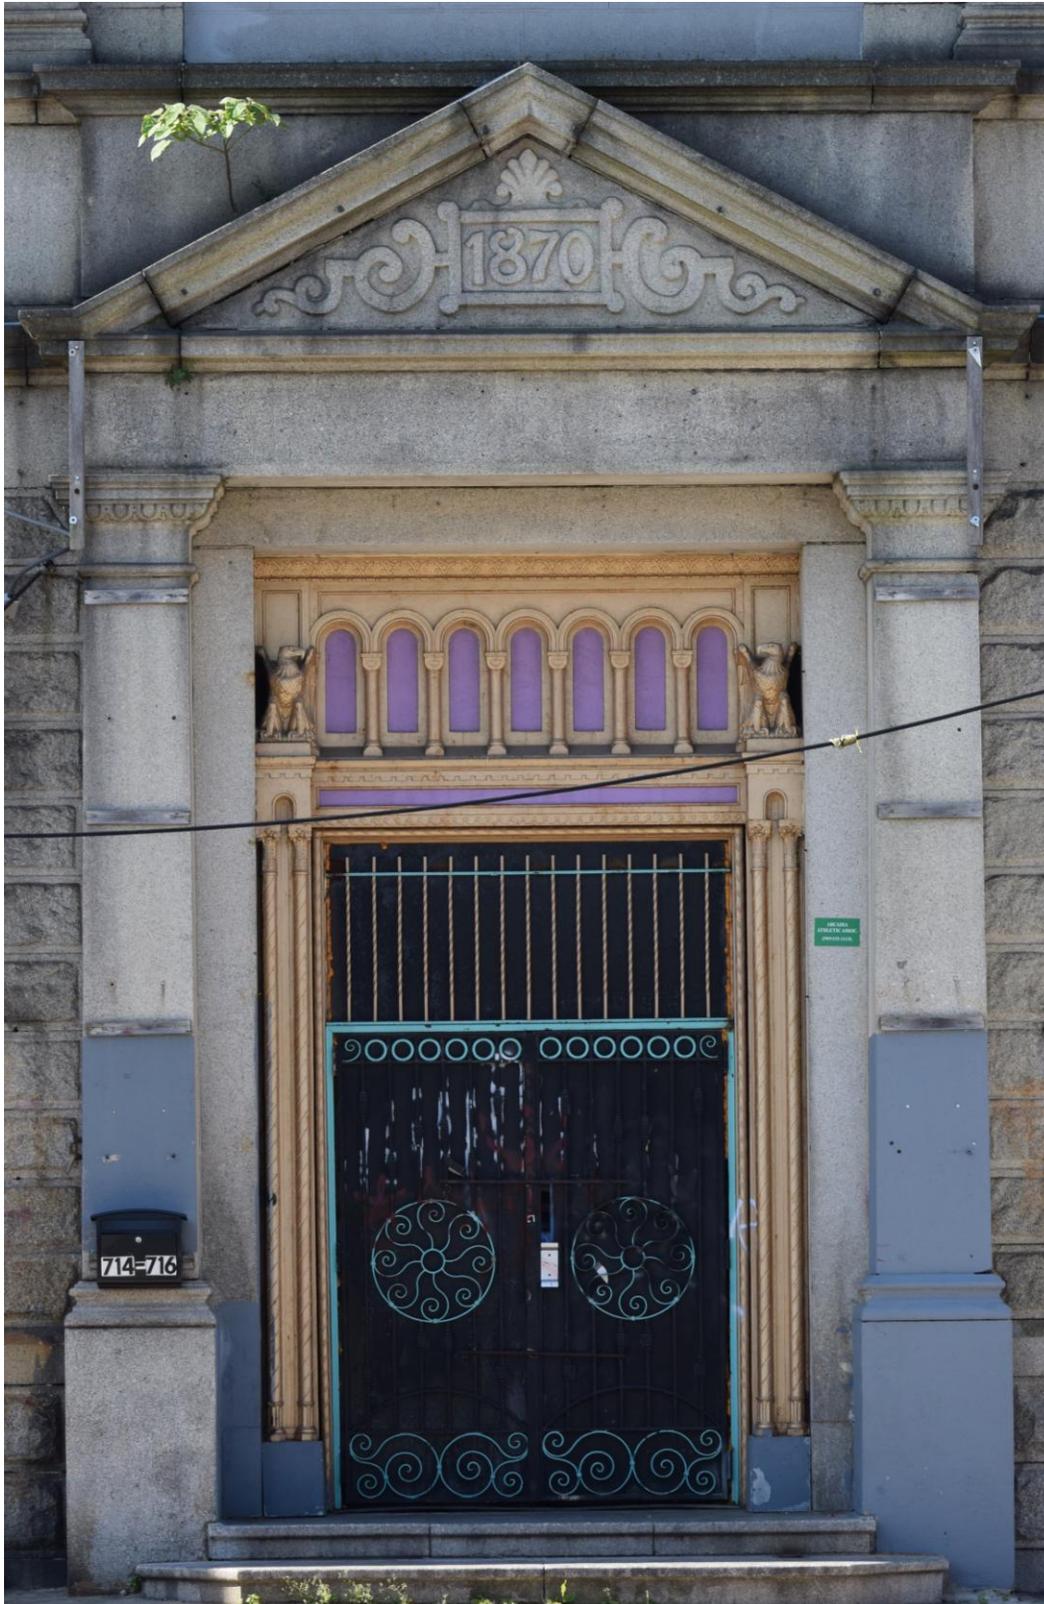
Figure 5: Elaborately decorated entryway to the National Security Bank. The “1870” over the doorway refers to the date of the bank’s founding, not the building’s construction. Photograph by author, 2017.

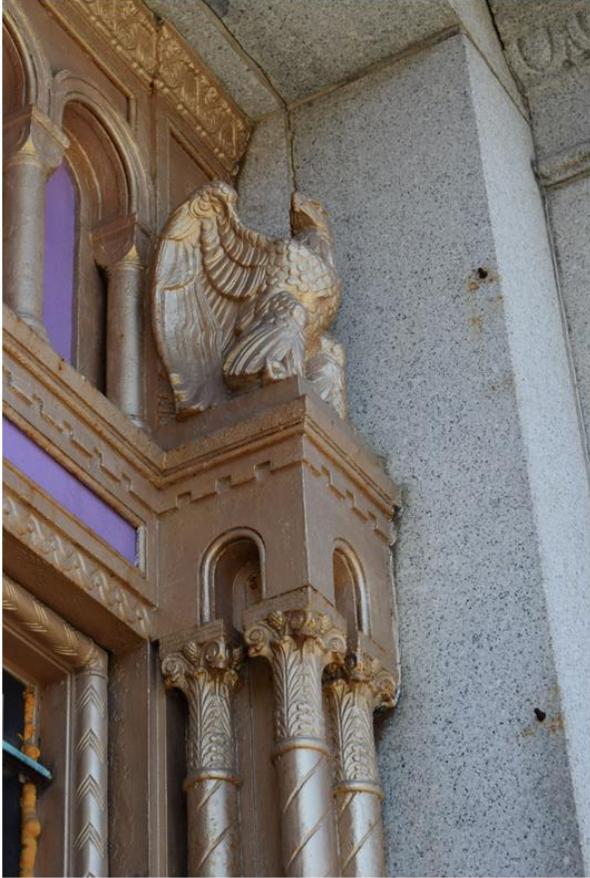
Figure 6: Detail view of the elaborately decorated entryway. Photograph by author, 2017.

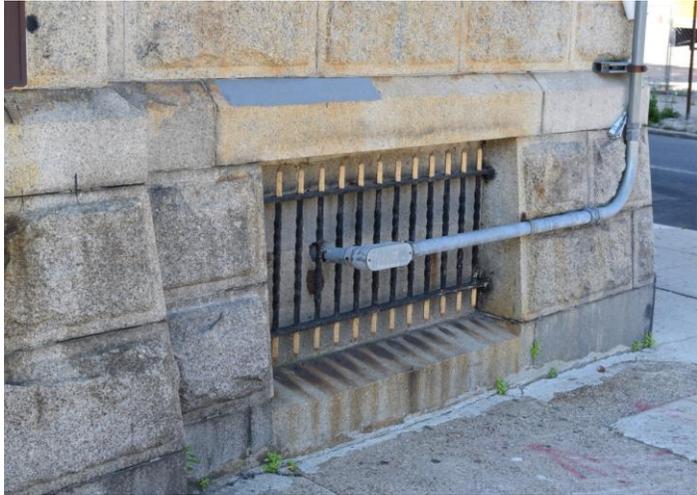
Figure 7: Detail view of the basement window guard. Photograph by author, 2017.

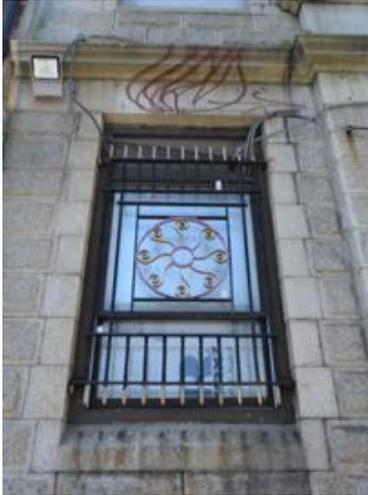
Figure 8: Detail view of the window guards that cover the first floor of the building. Photograph by author, 2017.

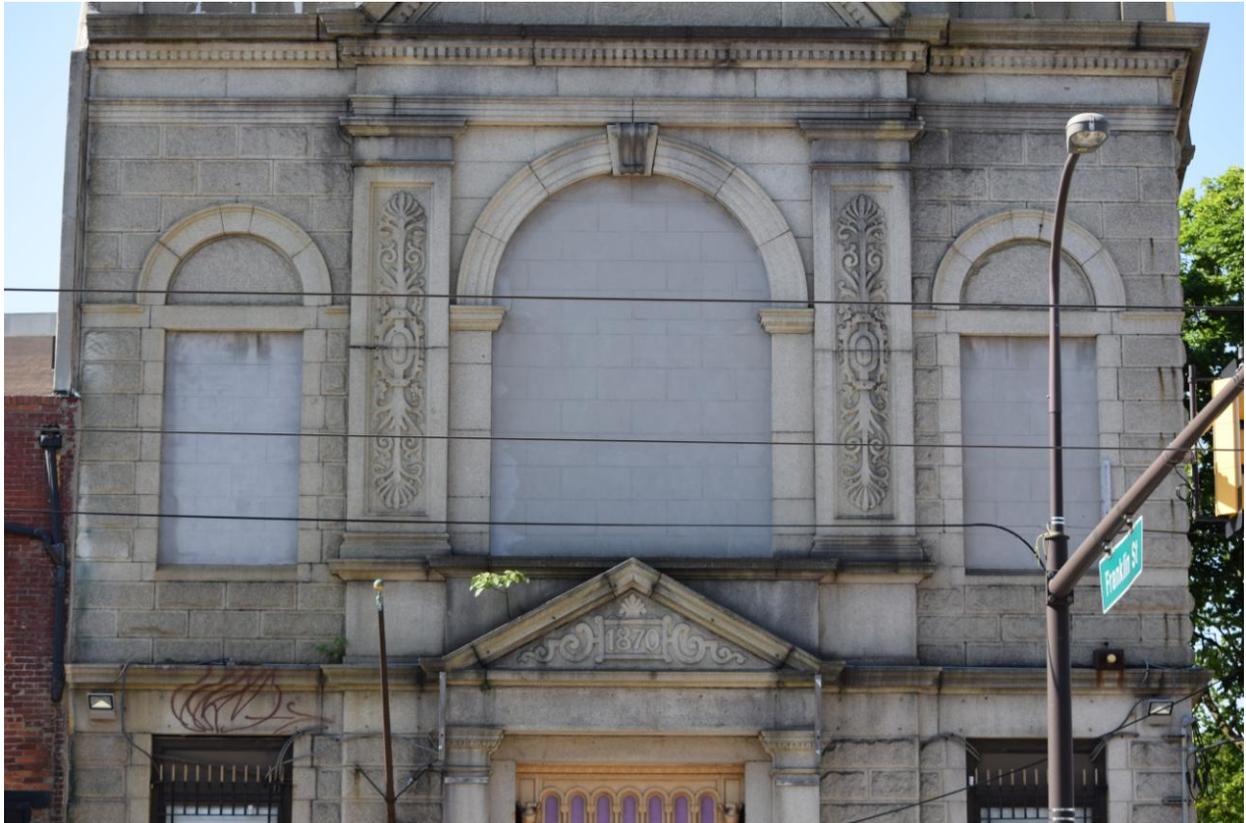
Figure 9: Second floor of the façade. Photography by author, 2017.

The second floor of the façade (fig. 9) matches the arrangement of the fenestration on the first floor. A large arched window, with keystone, begins directly above the first floor's door pediment. On either side of the window are pilasters with flattened foliate motifs. Windows on either side of the central window are simplified versions of the central window, though they lack its pilasters and keystone. All three windows are missing their original stained glass. The entablature (fig. 10) includes a dentiled cornice. Above the entablature is a parapet with found finials. A gable rises in front of the parapet. Within the tympanum of the gable is a continuation of the dentiled cornice and strapwork highlighting the initials "NSB". The gable is capped with a filial.

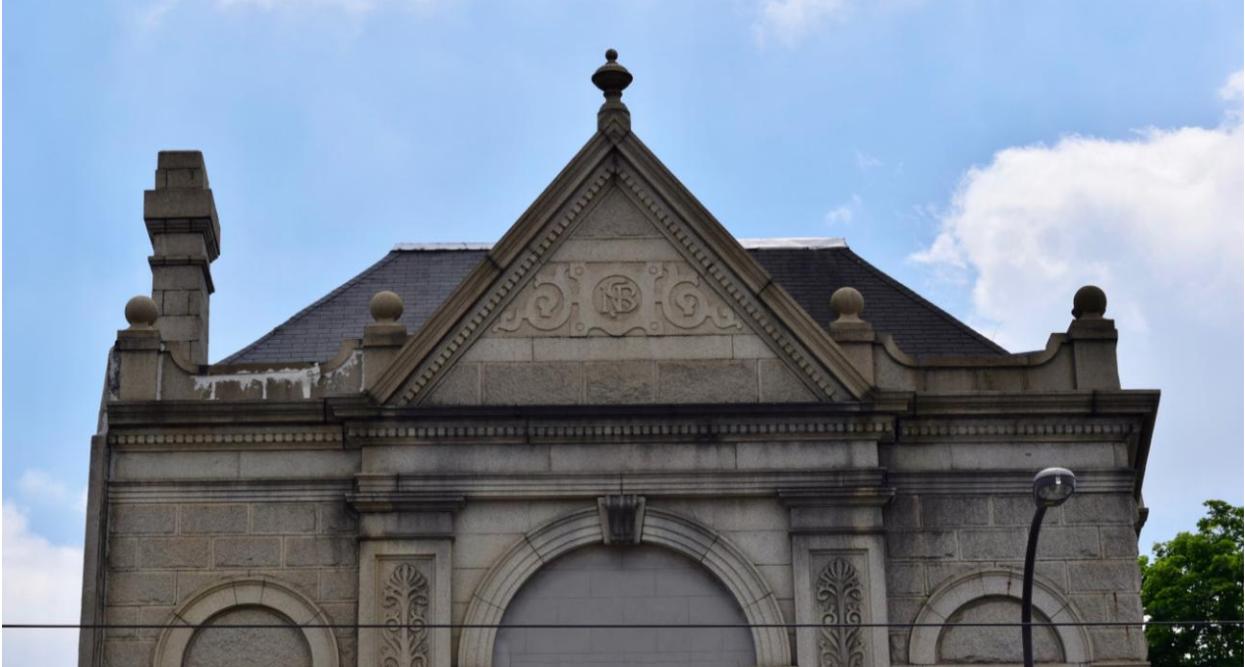
Figure 10: Entablature, gable, and roof as seen from West Girard Avenue. Photograph by author, 2017.

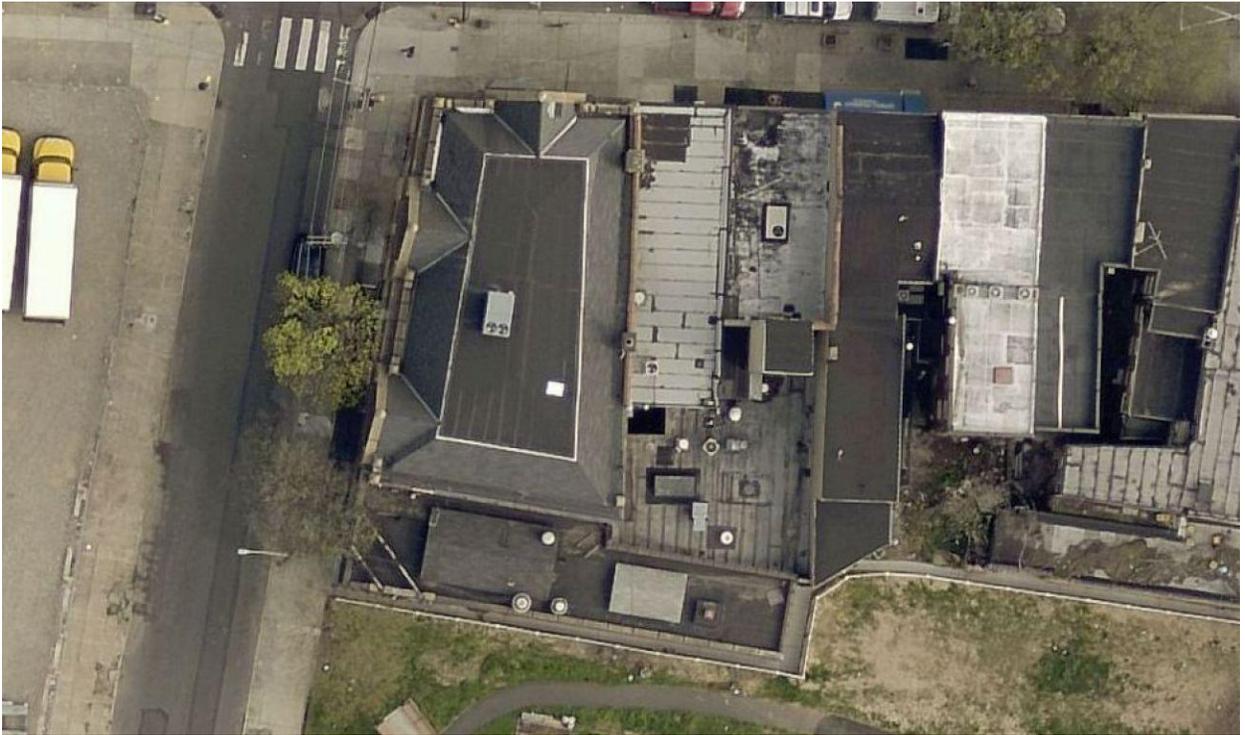
The roof (fig. 11) is hipped and covered in asphalt shingles, almost certainly not original though they resemble the shingles in early photographs of the building (Fig. 1, Appendix). Flashing covers the apex of the roof, potentially covering the “spines” that were once part of the original design. Additional finials visible in historic photographs (Appendix) have been removed. A decorative chimney is visible at the eastern edge of the building on the West Girard Avenue side of the building.

Figure 11: Roof. Aerial image from Picometry, courtesy the Philadelphia Historical Commission.

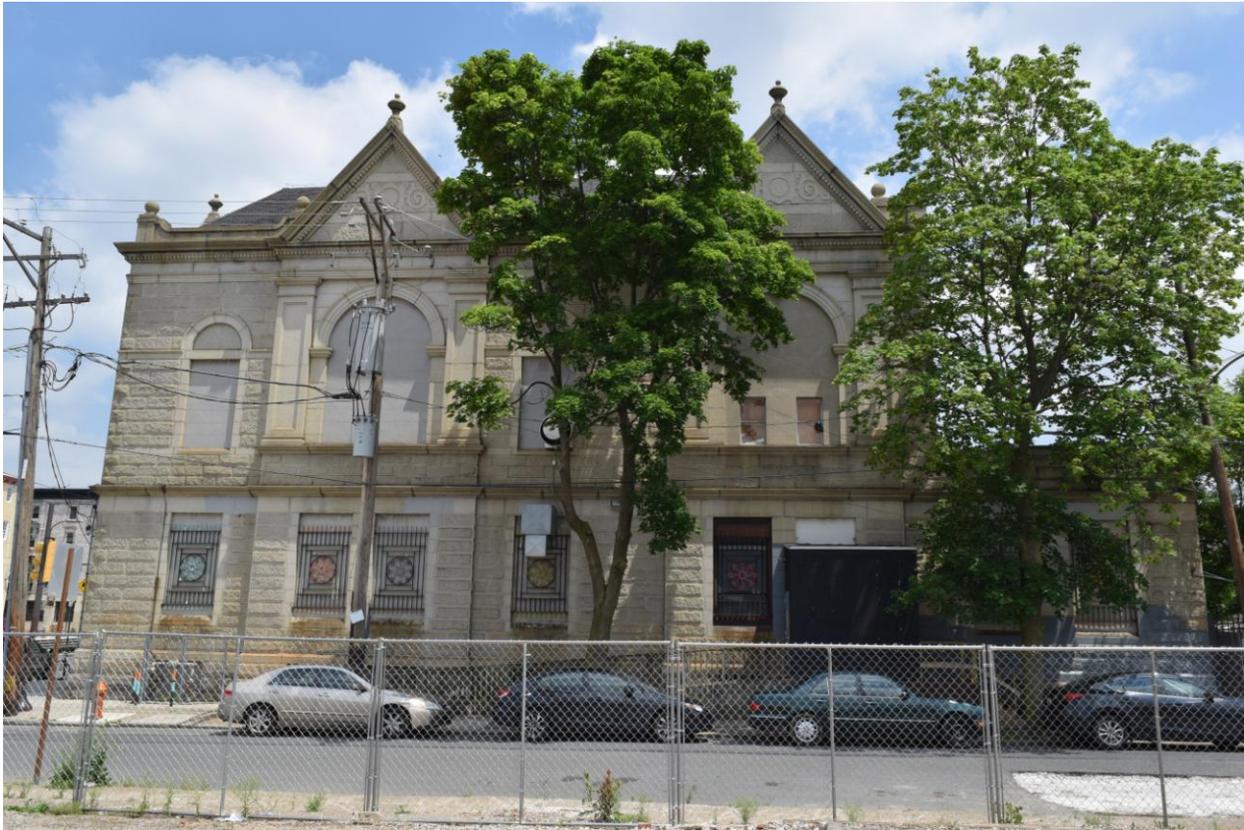
Figure 12: West elevation along Franklin Street. View from the site of the former Astor Theater (previously the German Theater), demolished c. 2016.³ Photograph by author, 2017.

The west elevation (fig. 12), facing Franklin Street, in its first phase of construction mirrored the façade with the addition of an extra center bay at the southern end. The only notable differences are in the center bay with the replacement of the main entrance door with two windows centered directly underneath the larger round arch window, two smaller windows at ground level to light the basement, and a slight reduction in decorative detail. The tympanum lacks the NSB initials seen in the façade, and the pilasters are missing their foliate motifs. The extra bay at the southern edge of the west elevation resembles the center bay, with its double window and larger round-arch window and gable. One of the first-floor windows has been replaced by a modern wheelchair accessible entrance, with a ramp leading up to the entrance (fig 13). Unlike the façade, all the windows have been removed or covered, though two new windows have been inserted into the round arch window opening in the southernmost “central bay.” An exhaust hood and fan have also been put in through original window openings. A one-story two-bay 1923 addition (fig. 13) at the southern edge, is visually identical to the ground floor of the intact center bays on the western elevation.⁴ The guards in the 1923 addition are identical to the pre-1908 photographs, with the exception that the southernmost guard has been installed backwards.

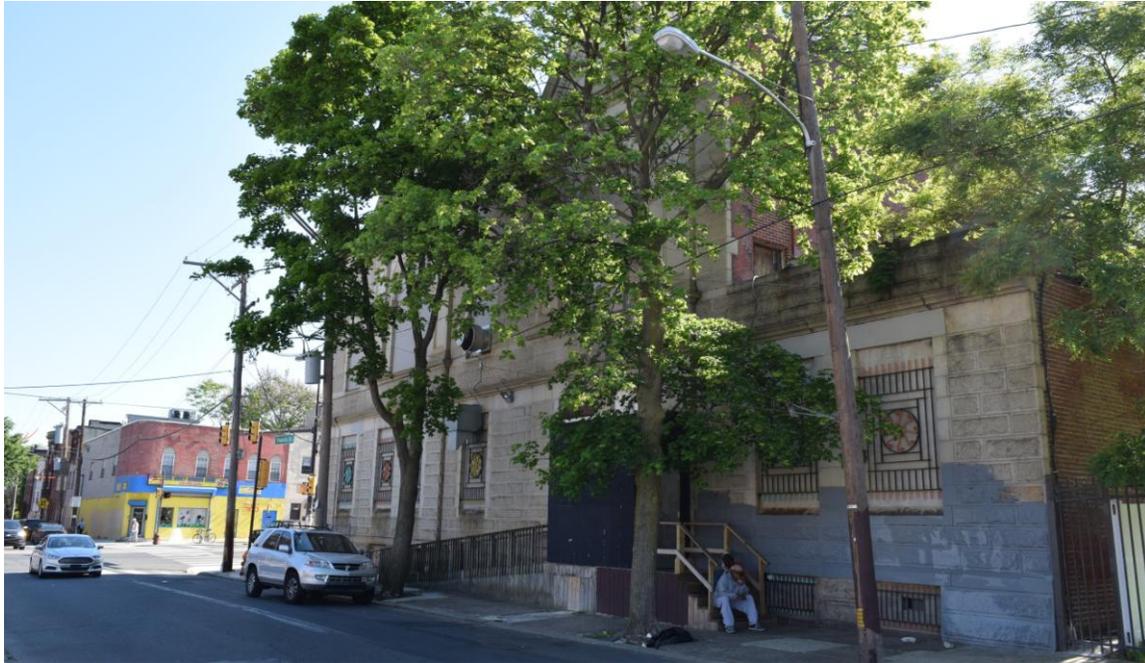
Figure 13: View of wheelchair-accessible entrance and 1923 addition. Photograph by author, 2017.

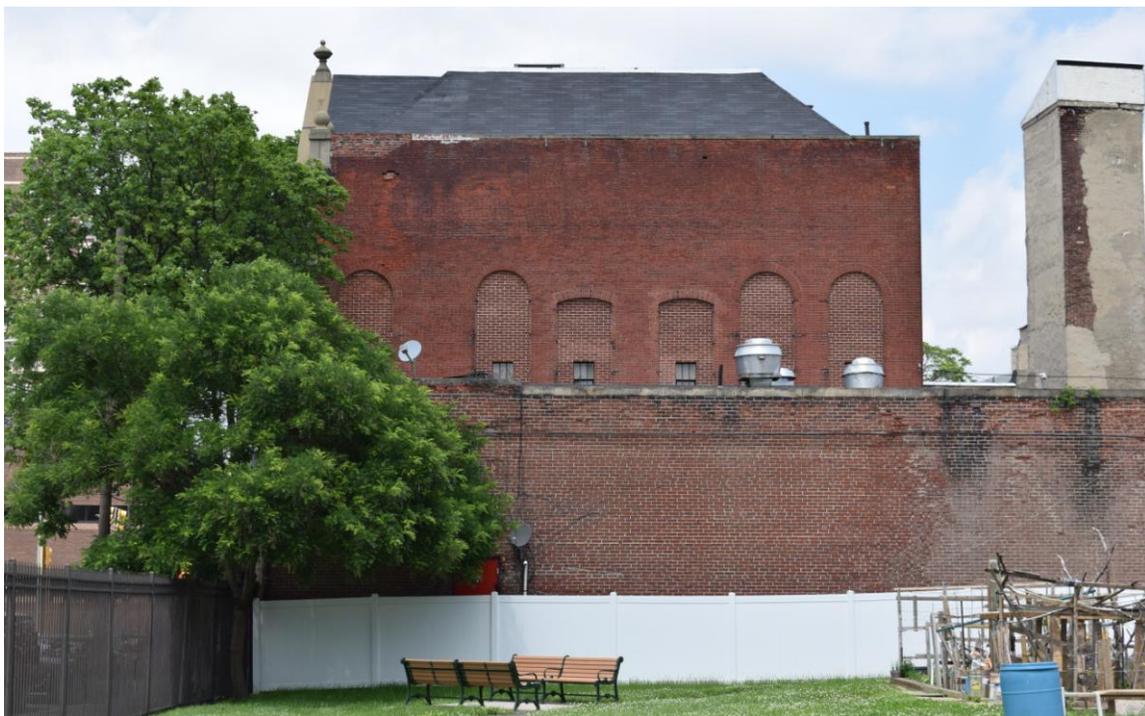
The brick-faced southern elevation (figs. 14, 15) is visible from Franklin Street as well as the publicly accessible gardens of the Urban Renewal era Ascension Manor complex. The one-story 1923 addition is windowless on its southern elevation. The second story of the 1887 building has six bricked up windows: two segmented arch, and four round arch windows.

Figure 14: Southern elevation. Photograph by author, 2017.

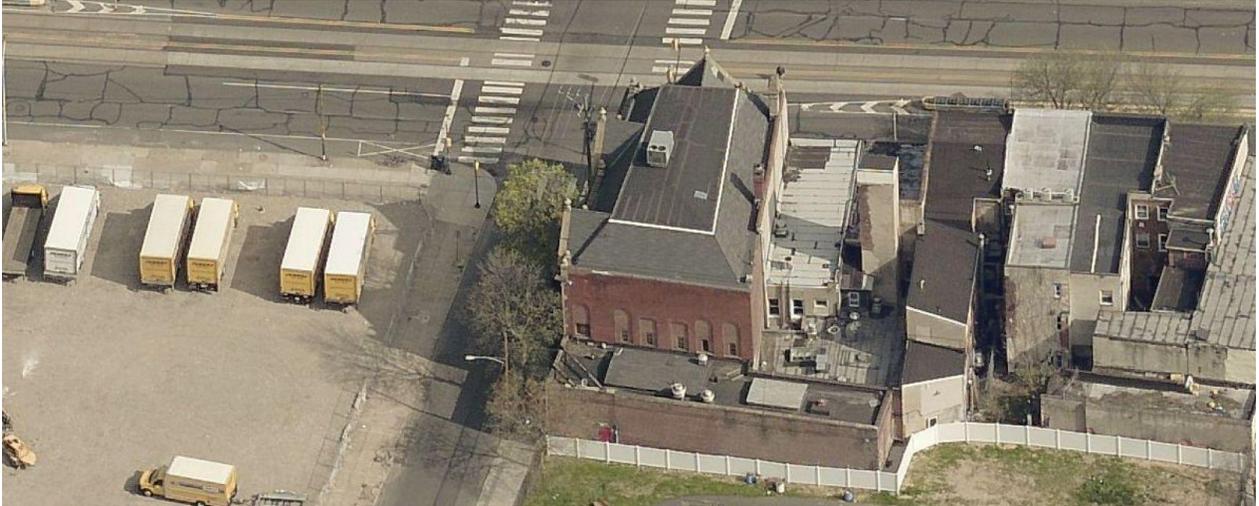
Figure 15: Aerial view of 714-16 West Girard Avenue. Aerial image from Picometry, courtesy the Philadelphia Historical Commission.

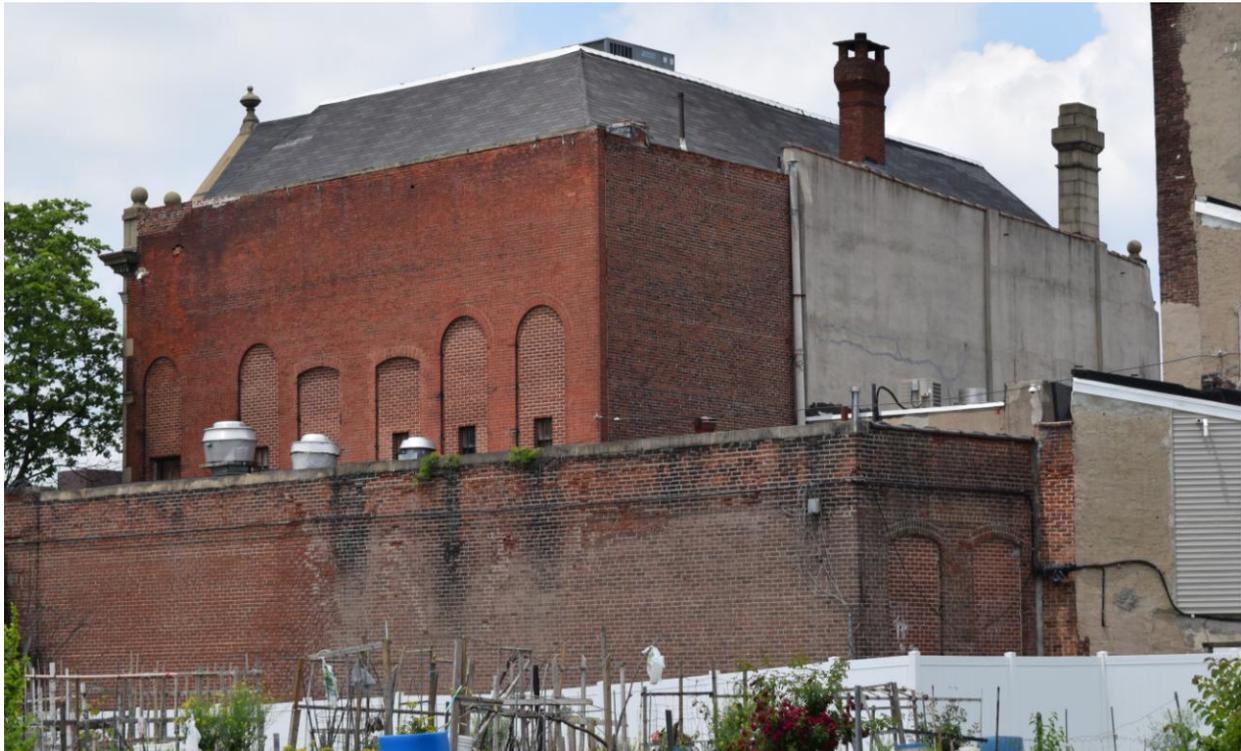
The eastern elevation is a party wall, however due to the reduction in height or the elimination of the neighboring buildings, it is now visible from Seventh Street (fig. 16). There are two segmented arch windows on the east side of the 1923 addition. There is also a second, red-brick chimney, and what appears to be the remnants of a third chimney visible at the roofline. According to the building announcement, all three chimneys were designed to be purely decorative.⁵

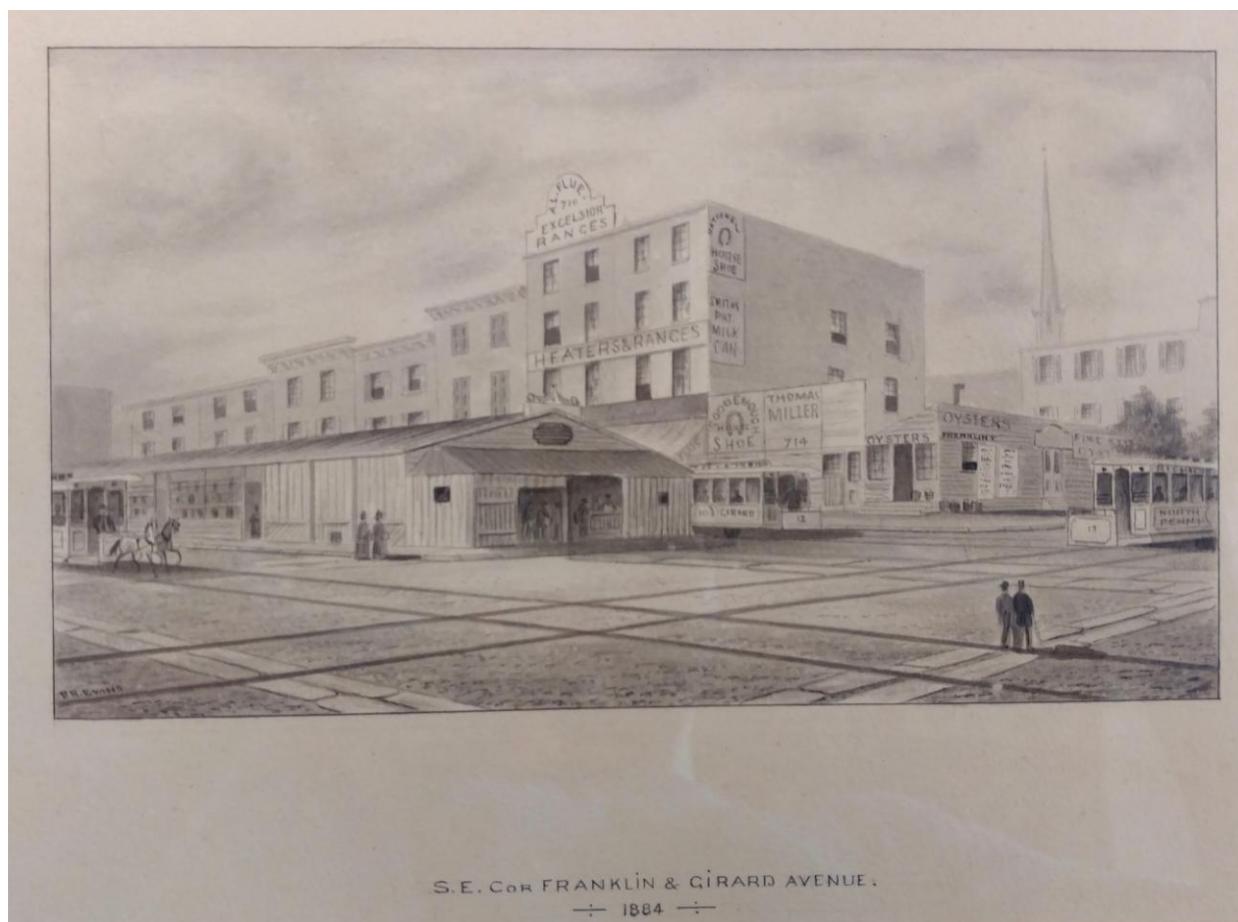
Figure 18: The southeast corner of Franklin and Girard in 1884. A shoe supply and an oyster shack occupy the future site of the National Security Bank. The adjacent building sells Excelsior Ranges, a product manufactured by Jacob Rechs.¹⁸ Image courtesy the Historical Society of Pennsylvania.

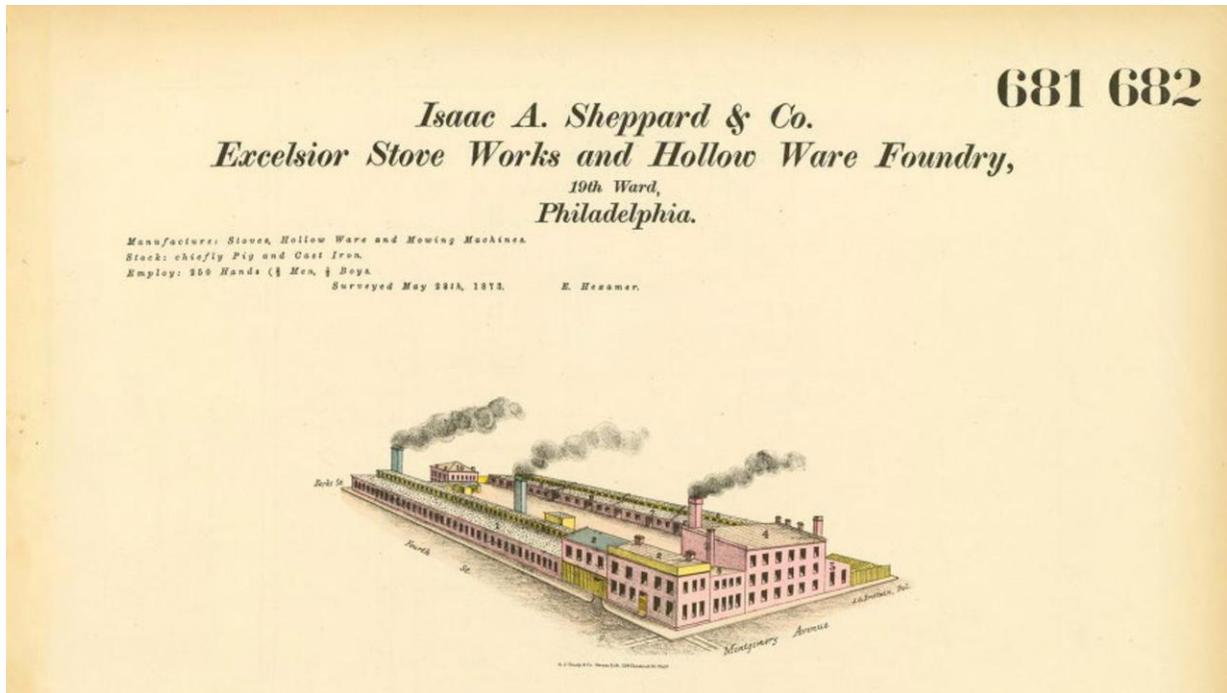
Figure 21: Isaac A. Sheppard & Co. Ironworks between Montgomery, Berks, 3rd and 4th Streets.³³ Hexamer General Surveys, Greater Philadelphia GeoHistory Network.

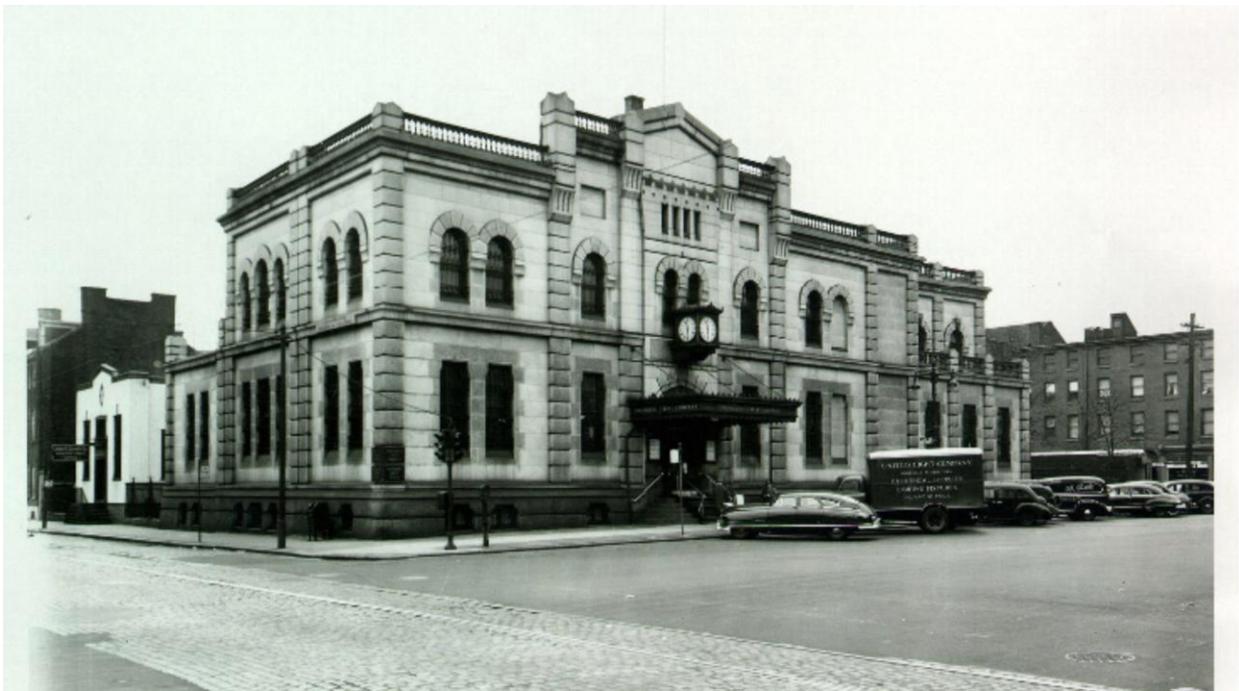
Figure 23: Northern Saving Fund Society. c. 1871-73. Frank Furness, architect. Visible at the far left is the now demolished southern extension by Frank Rushmore Watson. Image courtesy the James Dillon Collection, Athenaeum of Philadelphia.

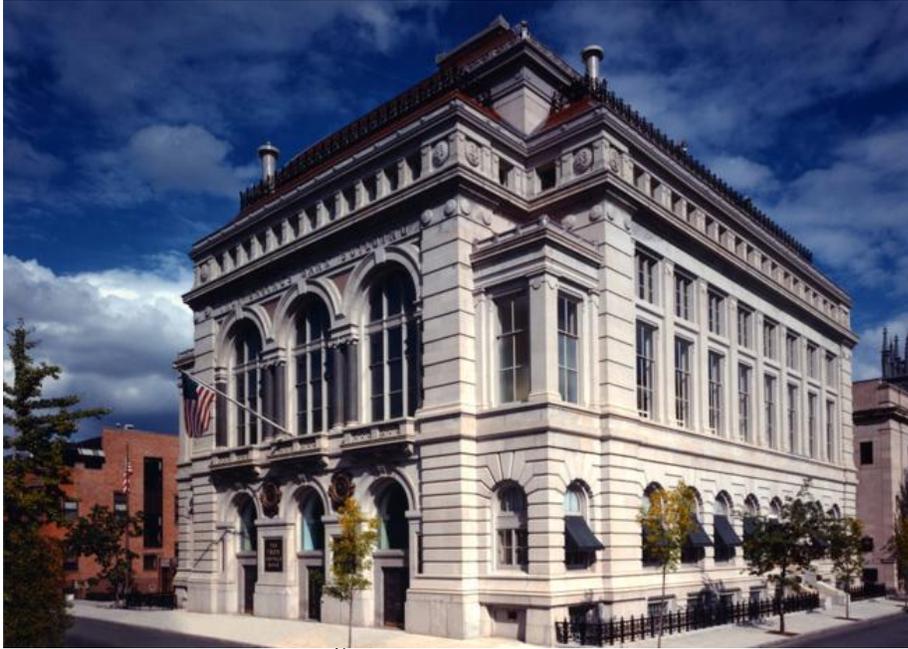
Figure 24: Troy Savings Bank.⁴⁶ Image courtesy architecture+.

However, while temples were passé, classicism was far from dead. The students of the Beaux-Arts trained Richard Morris Hunt spread his influence across America. George Post's Troy Savings Bank (1871) (fig. 24) and Williamsburgh Savings Bank (1875) (fig. 25) both embraced the Greco-Roman. Their choice of materials and rigid adherence to classical motifs could easily have been the inspiration for the National Security Bank. However, outside of Philadelphia, the clearest Beaux Arts inspiration for the National Security Bank is Hunt's Lenox Library (1871-77) (fig. 26). While a much larger building than the National Security Bank, both share a common set of design elements: the basement windows, tripartite window scheme with a slightly projecting central bay, gable with decorated tympanum, and the overall influence of Beaux-Arts Classicism.

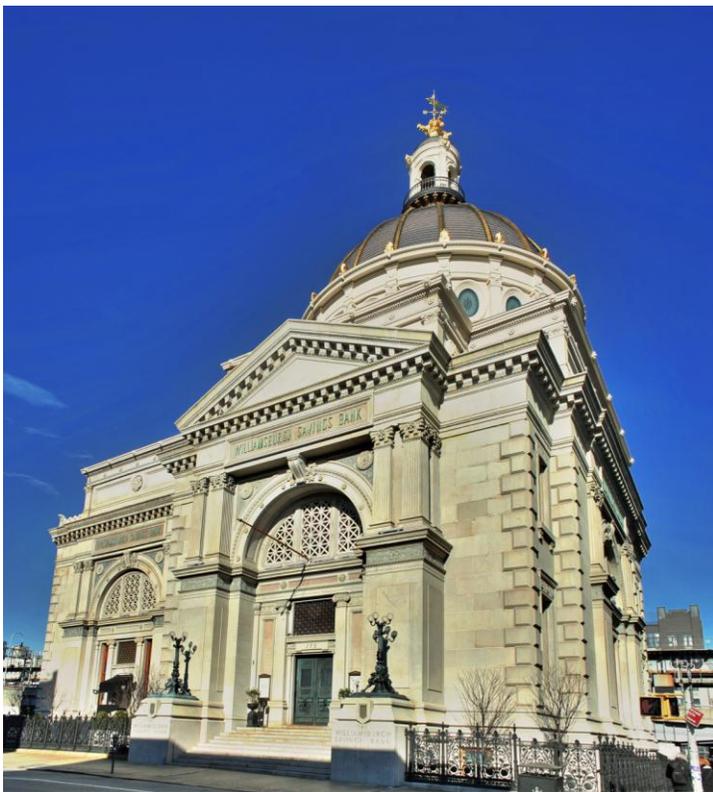
Figure 25: Williamsburgh Savings Bank.⁴⁷ Image courtesy Wikipedia.

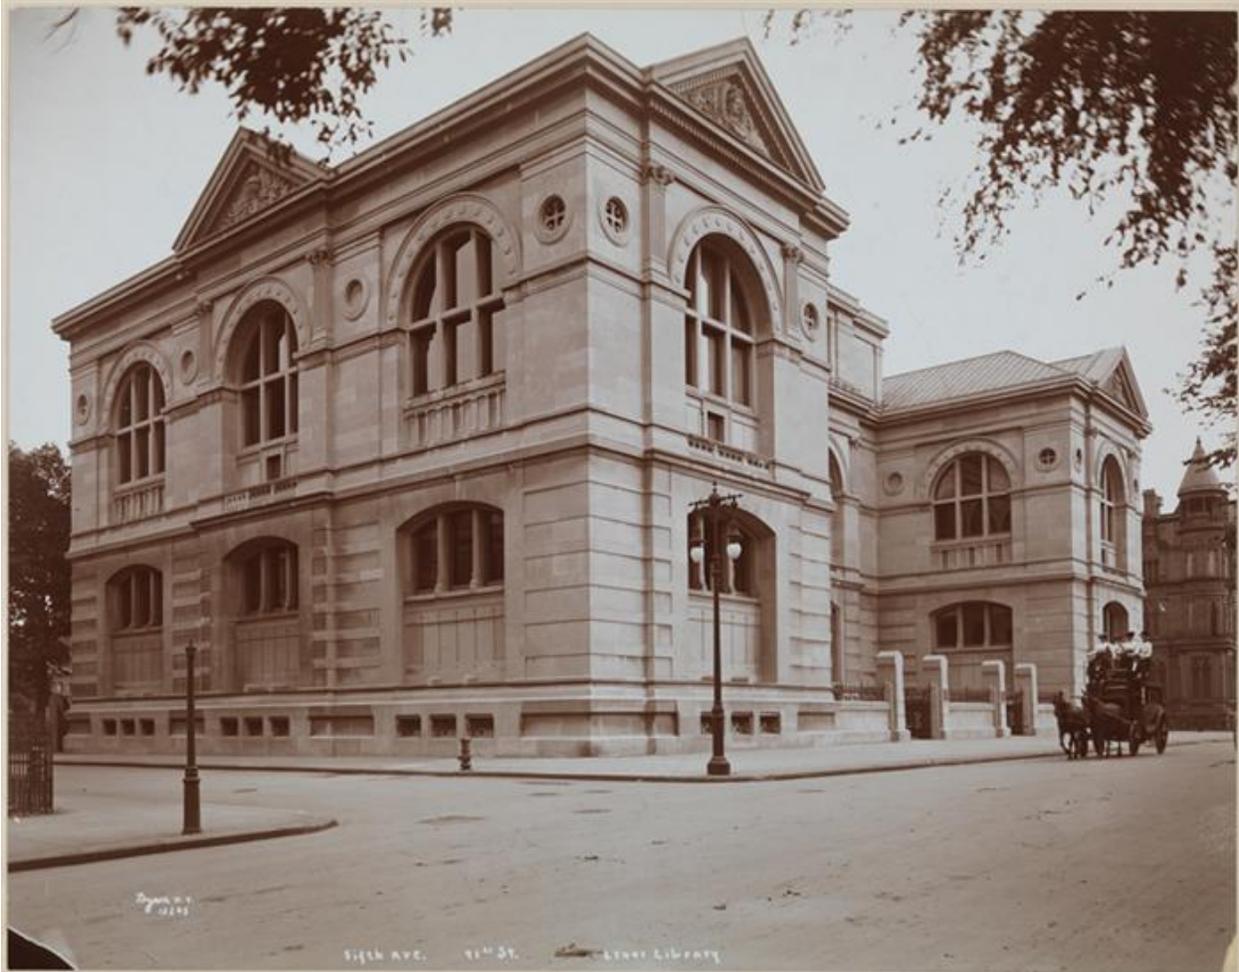
Figure 26: Lenox Library. 1871-77. Richard Morris Hunt, architect. Image courtesy the Museum of the City of New York.⁴⁸

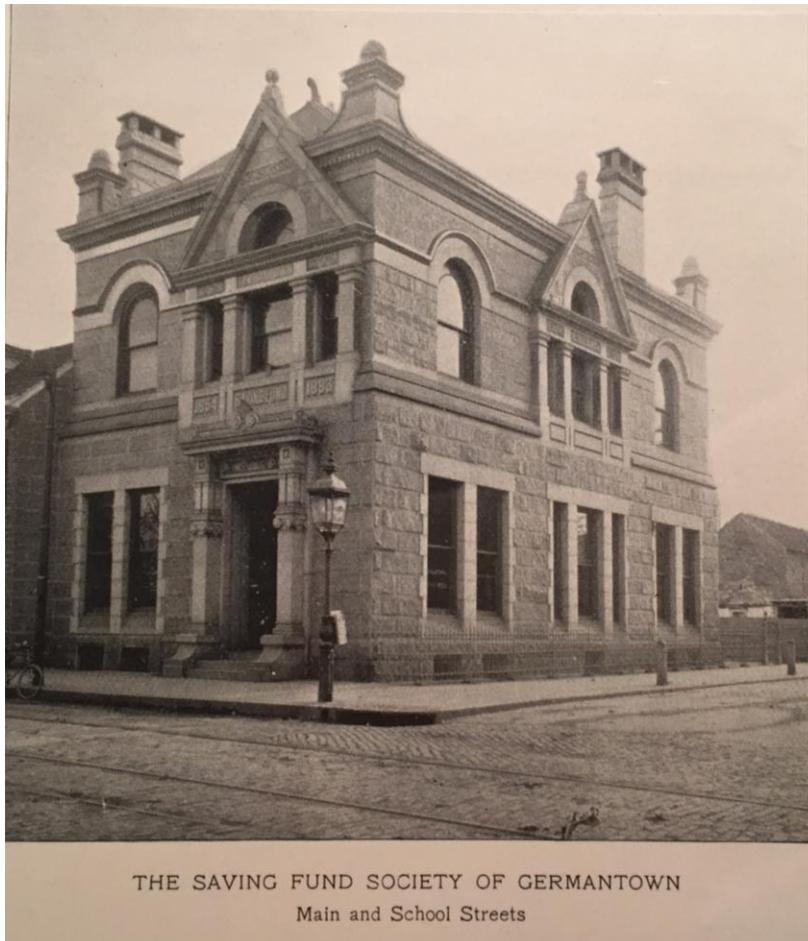
The bridge between the two buildings is The Saving Fund Society of Germantown (1883) (fig. 27), in appearance the Philadelphia predecessor to the National Security Bank. The connections between the two are unmistakable. The tripartite scheme, gables, chimneys, finials, and Fox Island granite rusticated ashlar are strikingly similar. Built by James H. Windrim only four years before the National Security Bank, its

Figure 27: The Saving Fund Society of Germantown. 1883. James H. Windrim. Image courtesy the Germantown Historical Society.
