**NOMINATION OF HISTORIC BUILDING, STRUCTURE, SITE, OR OBJECT
PHILADELPHIA REGISTER OF HISTORIC PLACES
PHILADELPHIA HISTORICAL COMMISSION**

Street address: 714-16 West Girard Avenue

Historic Name: National Security Bank

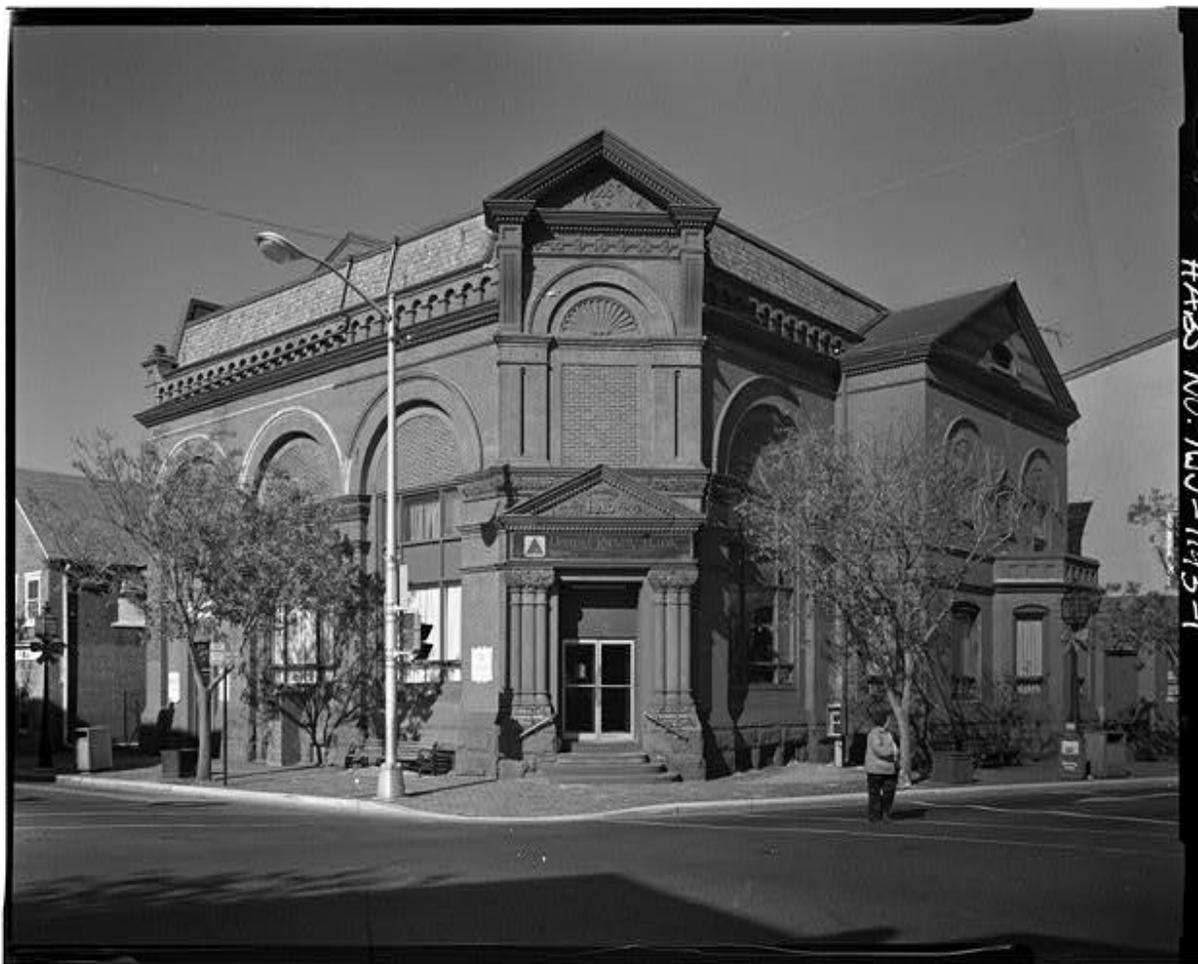
Other features justify the description of Romanesque. Built the year before, Hazelhurst and Huckel's Cumberland National Bank (fig. 28) shares many features with the National Security Bank. A corner building, like the National Security Bank, the Cumberland shares Richardsonian love of Palladian columns, decorative ironwork, gable with decorated tympanum, finials, and round arch windows. While it too struggles with the space constraints of the narrow lot, its approach is ultimately less graceful than the National Security Bank. The West Girard Avenue entrance (fig. 5) particularly justifies the description of Romanesque with its colonnade, eagles, and classical detail.

Figure 28: Cumberland National Bank: Hazelhurst and Huckel. Library of Congress, HABS <https://www.loc.gov/resource/hhh.nj1495.photos>

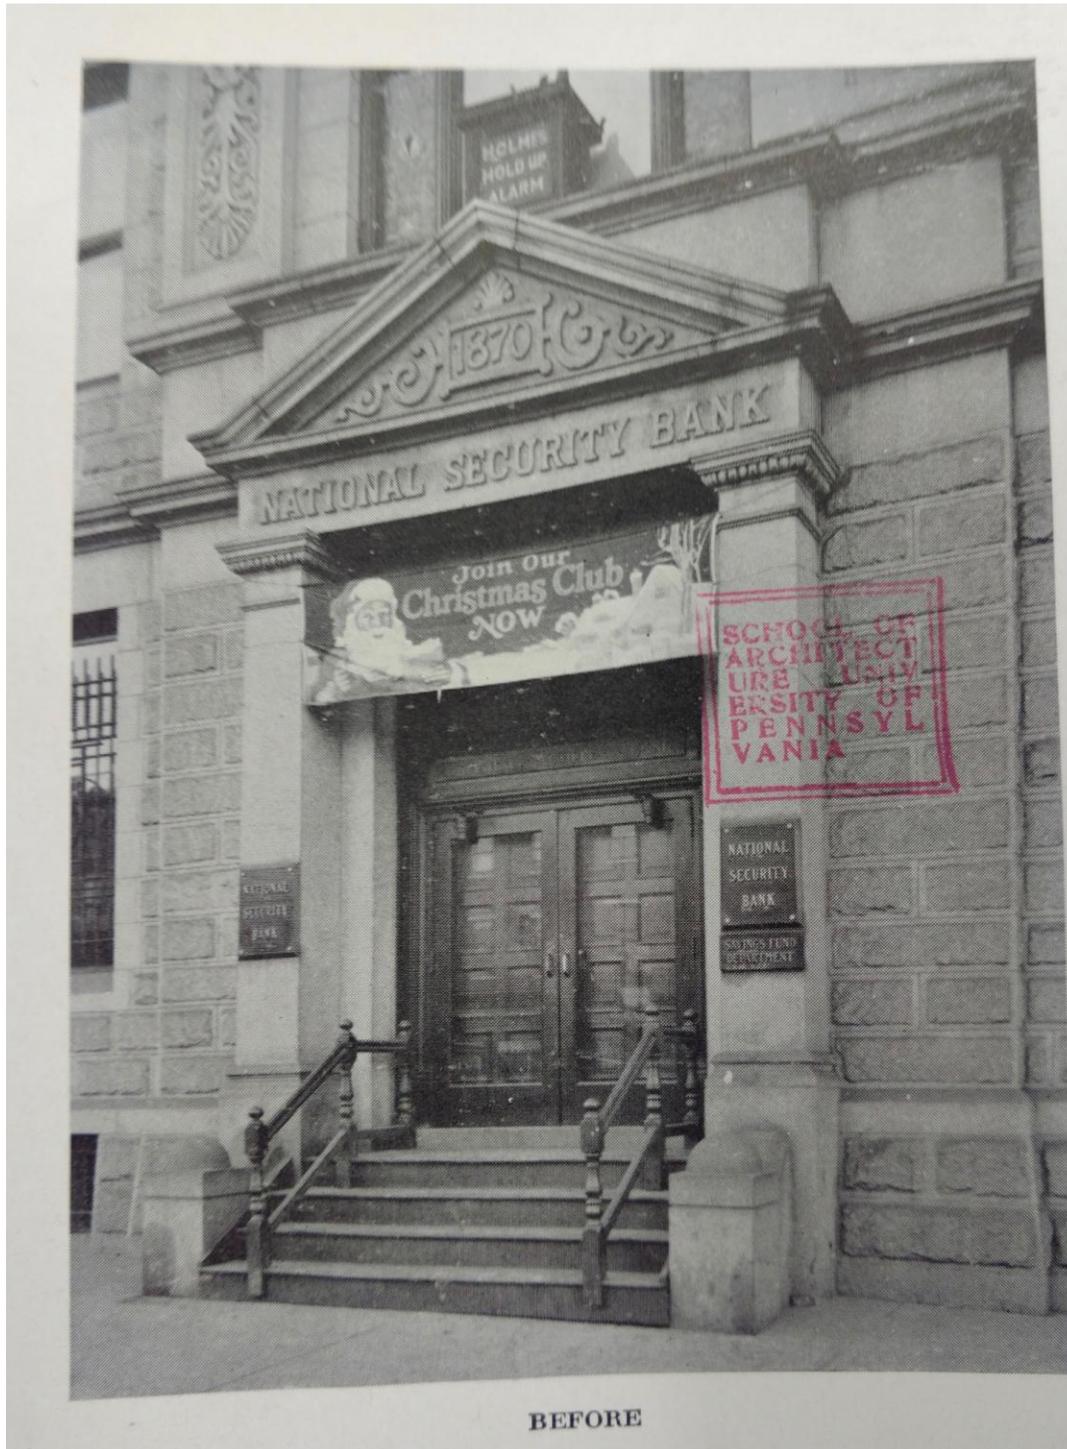
Figure 29: The National Security Bank prior to remodeling by Tilghman M. Moyer. Photograph pre-1934. Image courtesy the University of Pennsylvania.⁵³

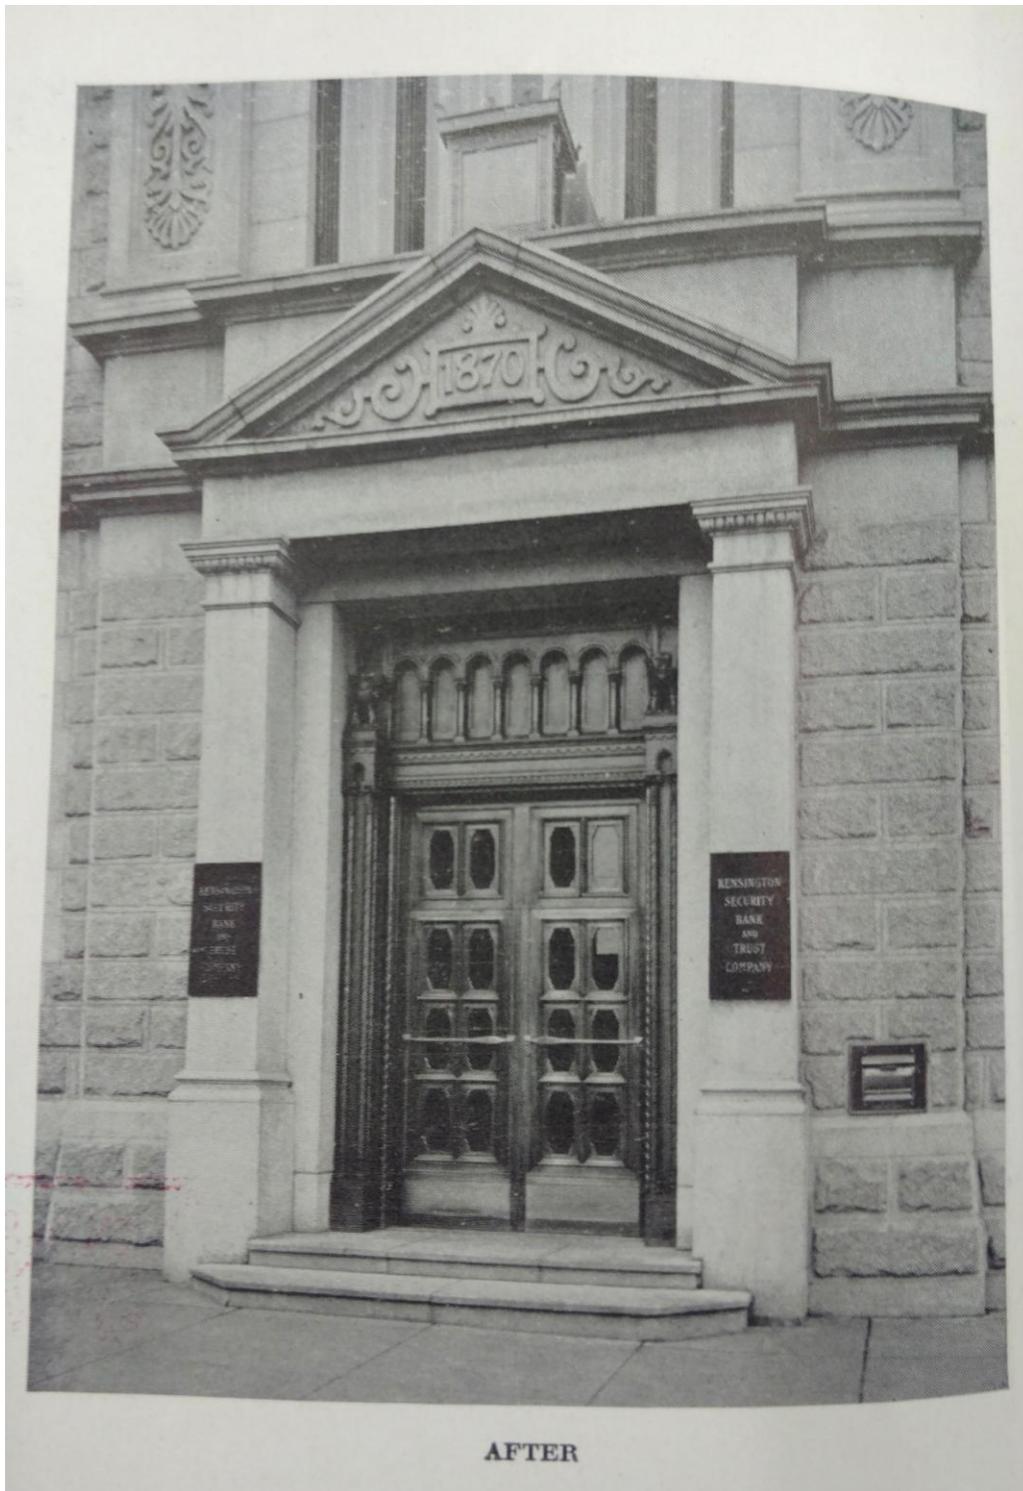
Figure 30: The National Security Bank after remodeling by Tilghman M. Moyer. Photograph c. 1931-33. Image courtesy the University of Pennsylvania.⁵⁴

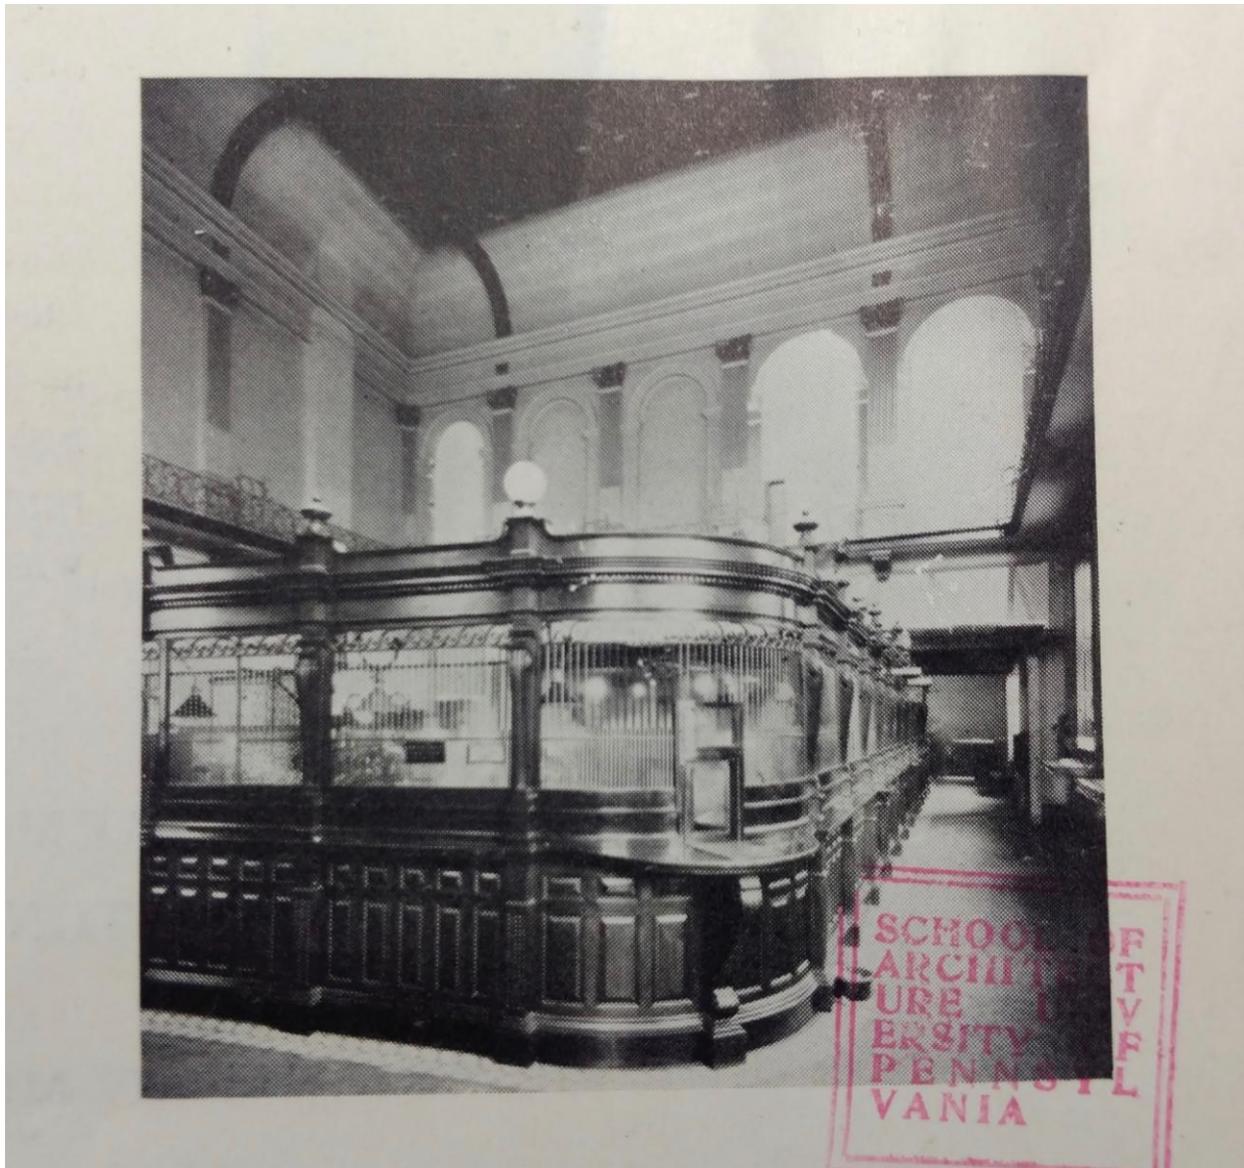
Figure 29: The National Security Bank prior to remodeling by Tilghman M. Moyer. Photograph pre-1934. Image courtesy the University of Pennsylvania.⁵⁵

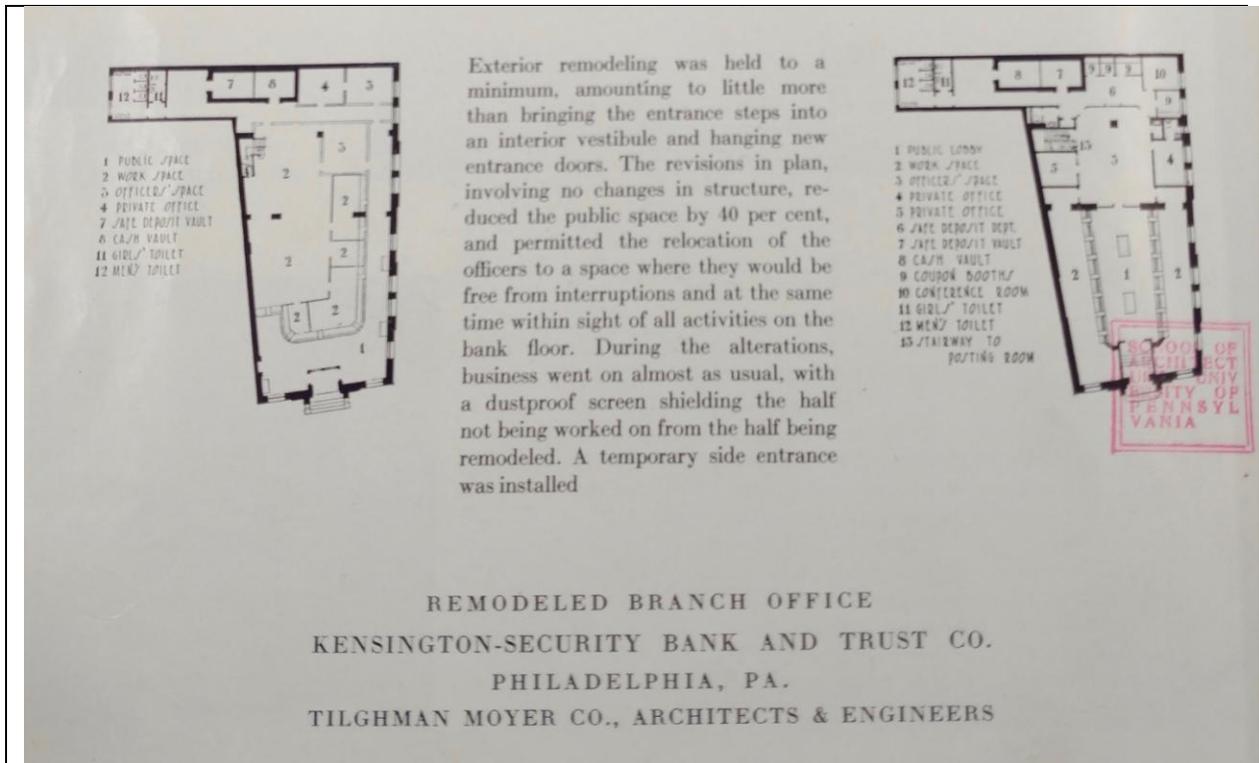
Figure 31: Plans for the National Security Bank before (left) and after (right) remodeling.

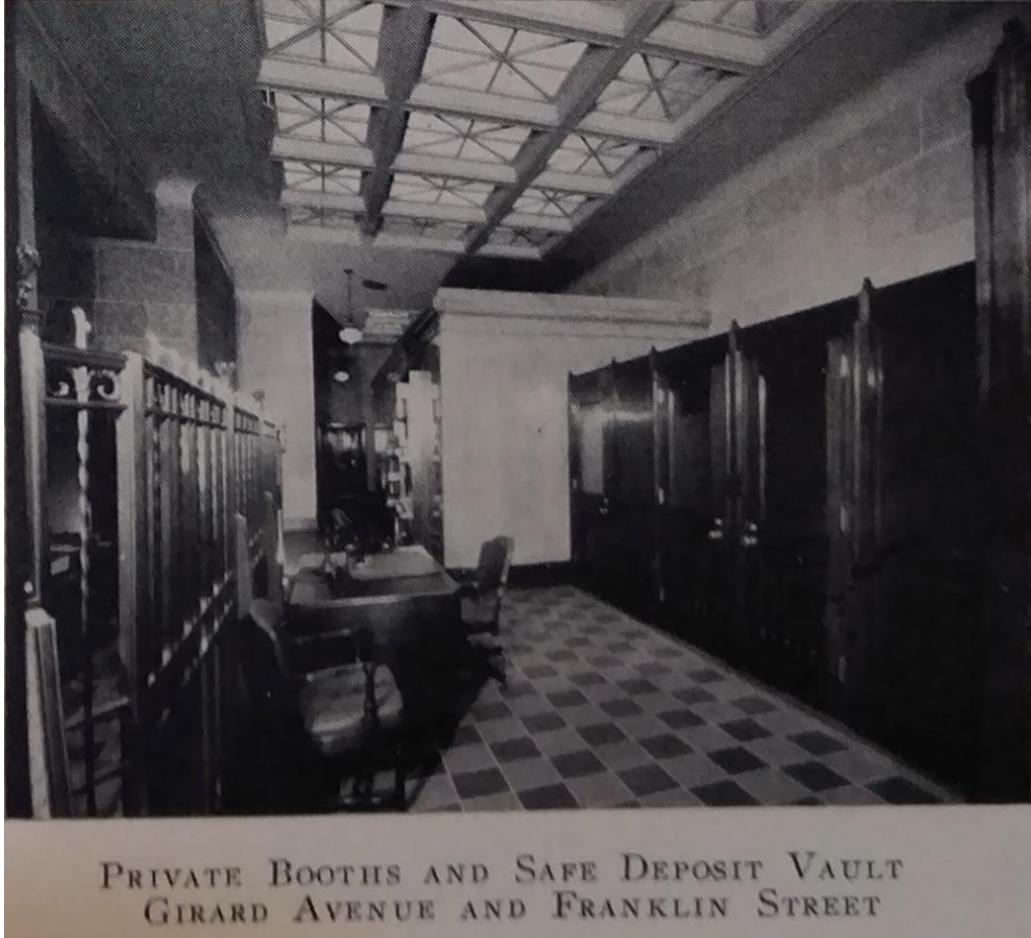
Figure 32: Interior of the National Security Bank c. 1931. Image Courtesy the Historical Society of PA.⁵⁷

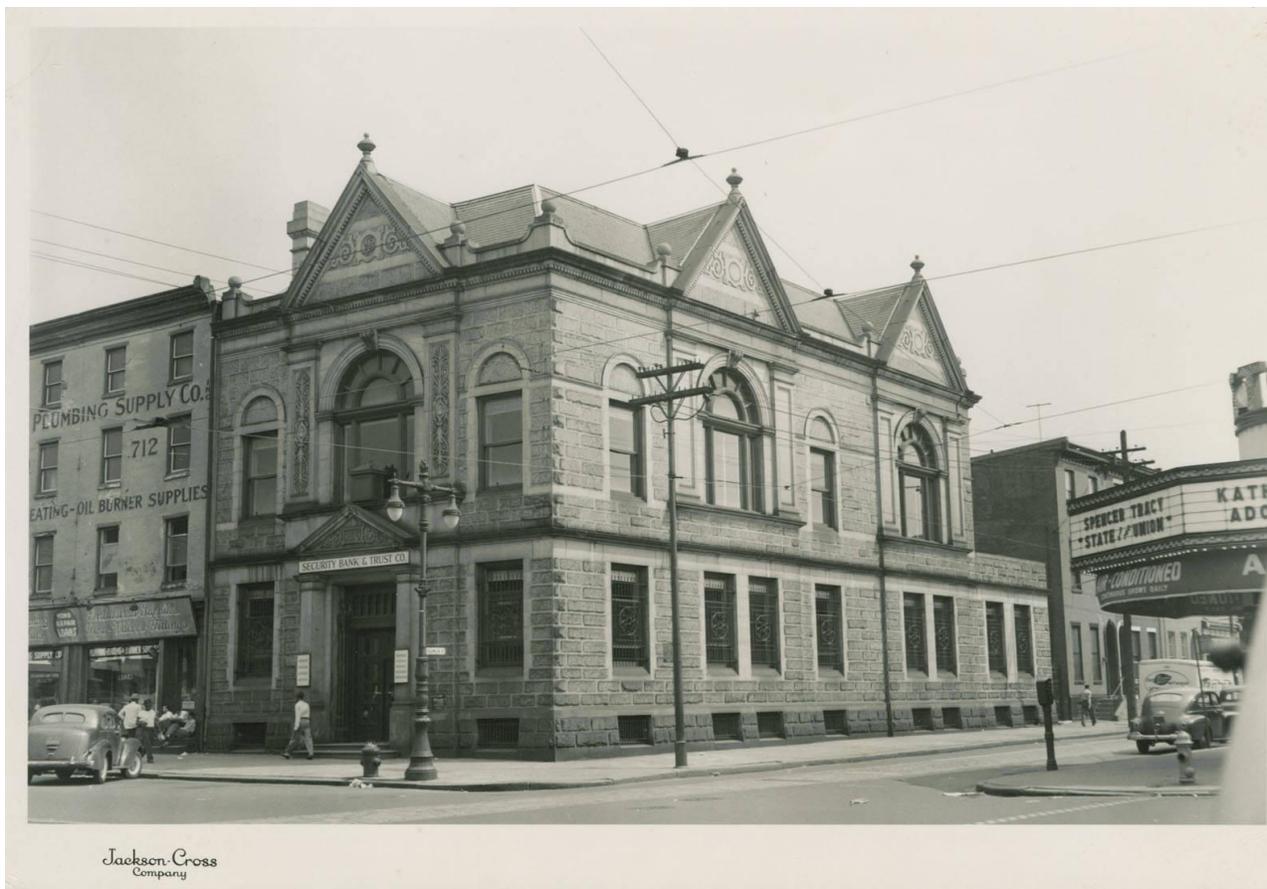
Figure: 34. National Security Bank Building c. 1948. The “spines” and finials have been removed. Image Courtesy the Library Company of Philadelphia.⁵⁹
